***Environmental and Runway Surface
Conditions During Friction Tests
at North Bay Airport:
January-February 2002***

LM-SMPL-2002-0220
TP 14158E

Nirmal K. Sinha

Prepared for
**Transportation Development Centre
and
Aerodrome Safety Branch
of
Transport Canada**

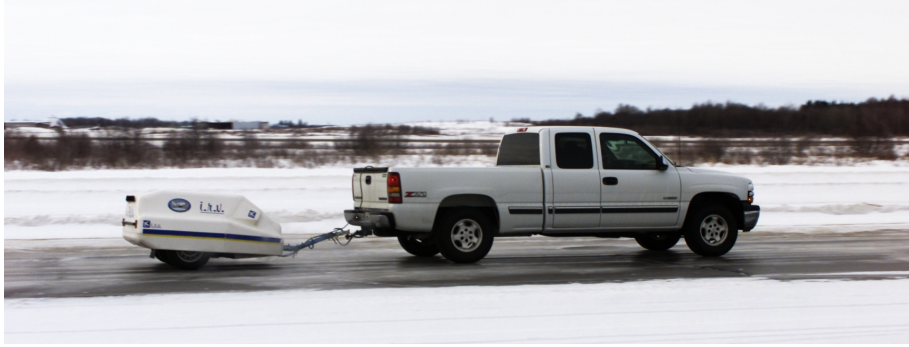
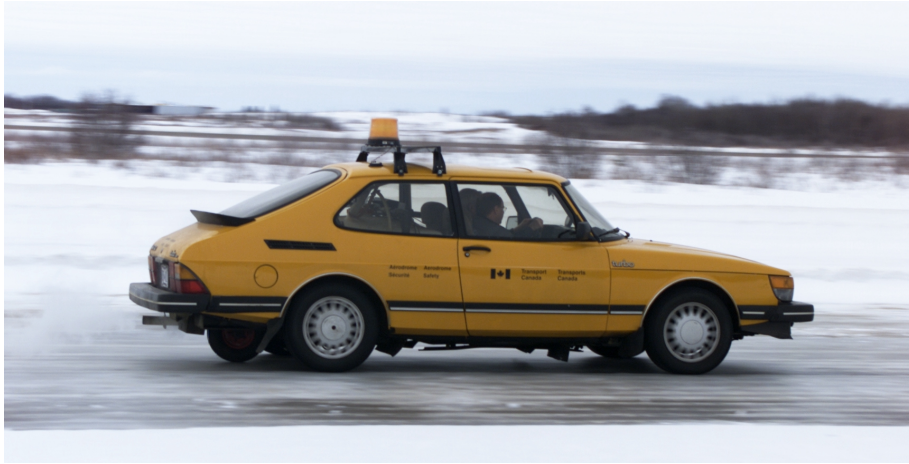
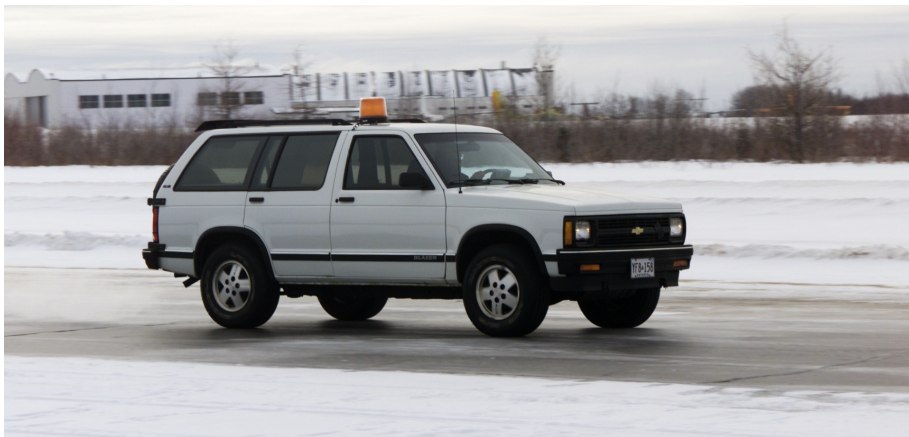
Figure 2. Three test vehicles: IRV (top), Transport Canada's SFT-Turbo (middle) and ERD (bottom) during the tests (410/411) on the ice strip on the west side of the north end of runway 13-31 on 29 January 2002

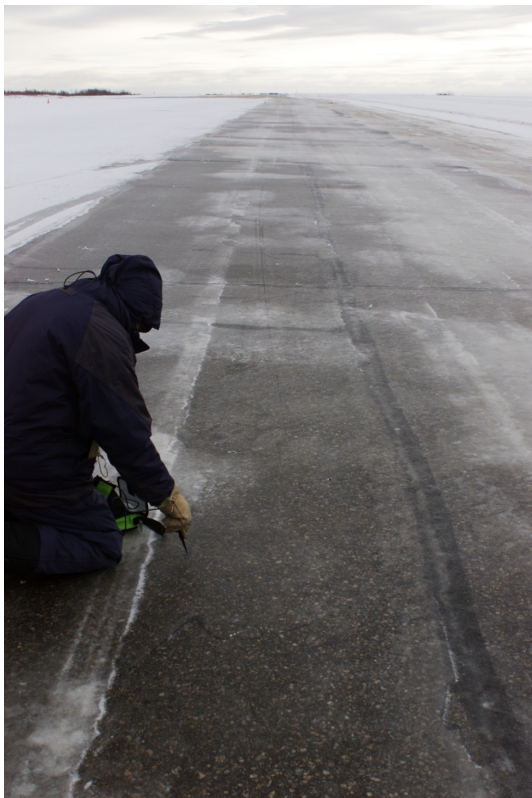
Jan. 29, 2001, 09:20
 North Bay, Ontario
 Test #02.29.01
 Project 410
 Runway 1331, West Side, 31 Direction
 IRV / ERD Comparison, Variable Slip on ICE

Man-made Ice Test Surface
 Conditions Before Testing:
 Air Temp. -16.5
 Surface Temp. -11.0 to 11.2
 IRV, ERD, TCFST-TURBO

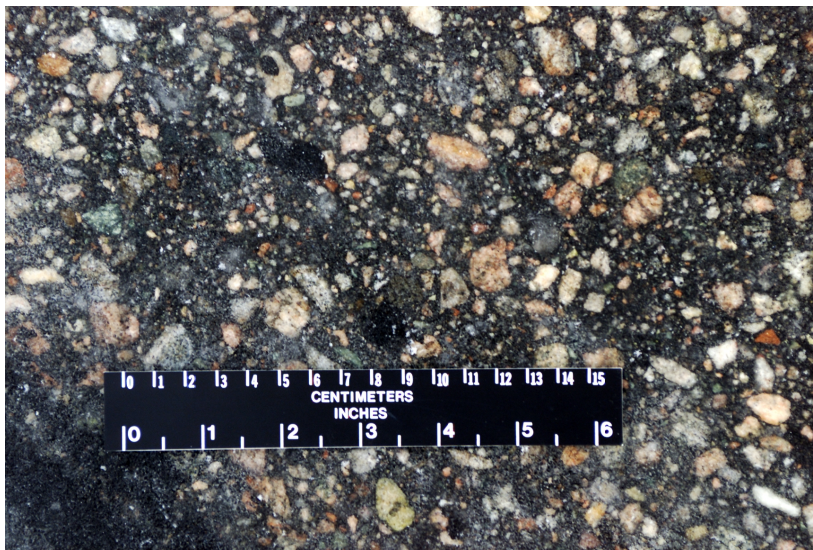
Jan. 29, 2001, 09:20
 North Bay, Ontario
 Test #02.29.01
 Project 410
 Runway 1331, West Side, 31 Direction
 IRV / ERD Comparison, Variable Slip on ICE

Man-made Ice Test Surface
 Conditions Before Testing
 Air Temp. -16.5
 Surface Temp. -11.0 to 11.2
 IRV, ERD, TCFST-TURBO
 Detail of Thin, Clear Ice

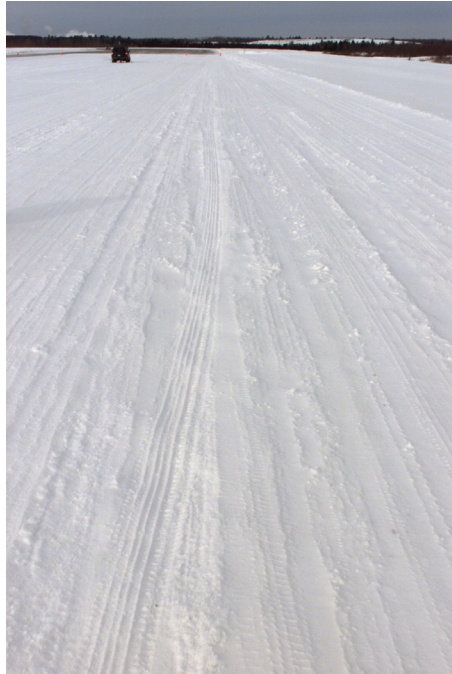
Jan, 29,2001, 10:45
 North Bay, Ontario
 Test #02, Project 411
 Test #02, 131 Direction
 IRV/ERD Comparison
 Variable Slip on COMPACTED SNOW

Compacted Snow Test Surface
 Conditions After Second Series:
 Rolling and Damage from testing
 Air Temp: -10.8 C to -11.6 C
 Surface Temp: -10.8 C to -11.6 C
 IRV, ERD, TCST, URBO

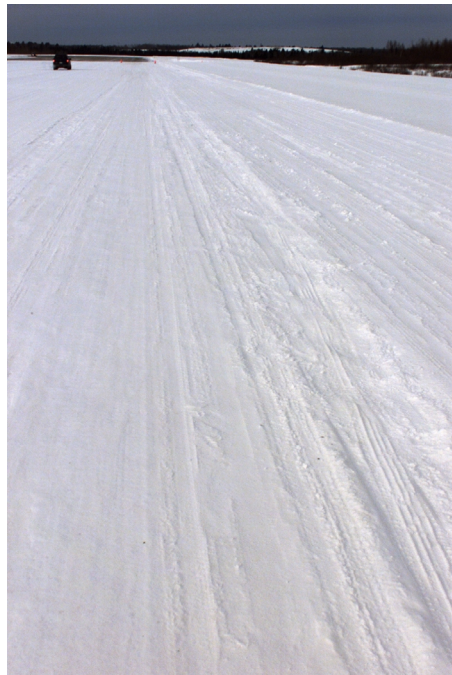
Jan, 29,2001, 11:18
 North Bay, Ontario
 Test #02, Project 411
 Test #02, 131 Direction
 IRV/ERD Comparison
 Variable Slip on COMPACTED SNOW

Compacted Snow Test Surface
 Conditions After Third Series
 Air Temp: -14.4 C
 Surface Temp: -11.1 C to -11.6 C
 IRV, ERD, TCST, URBO

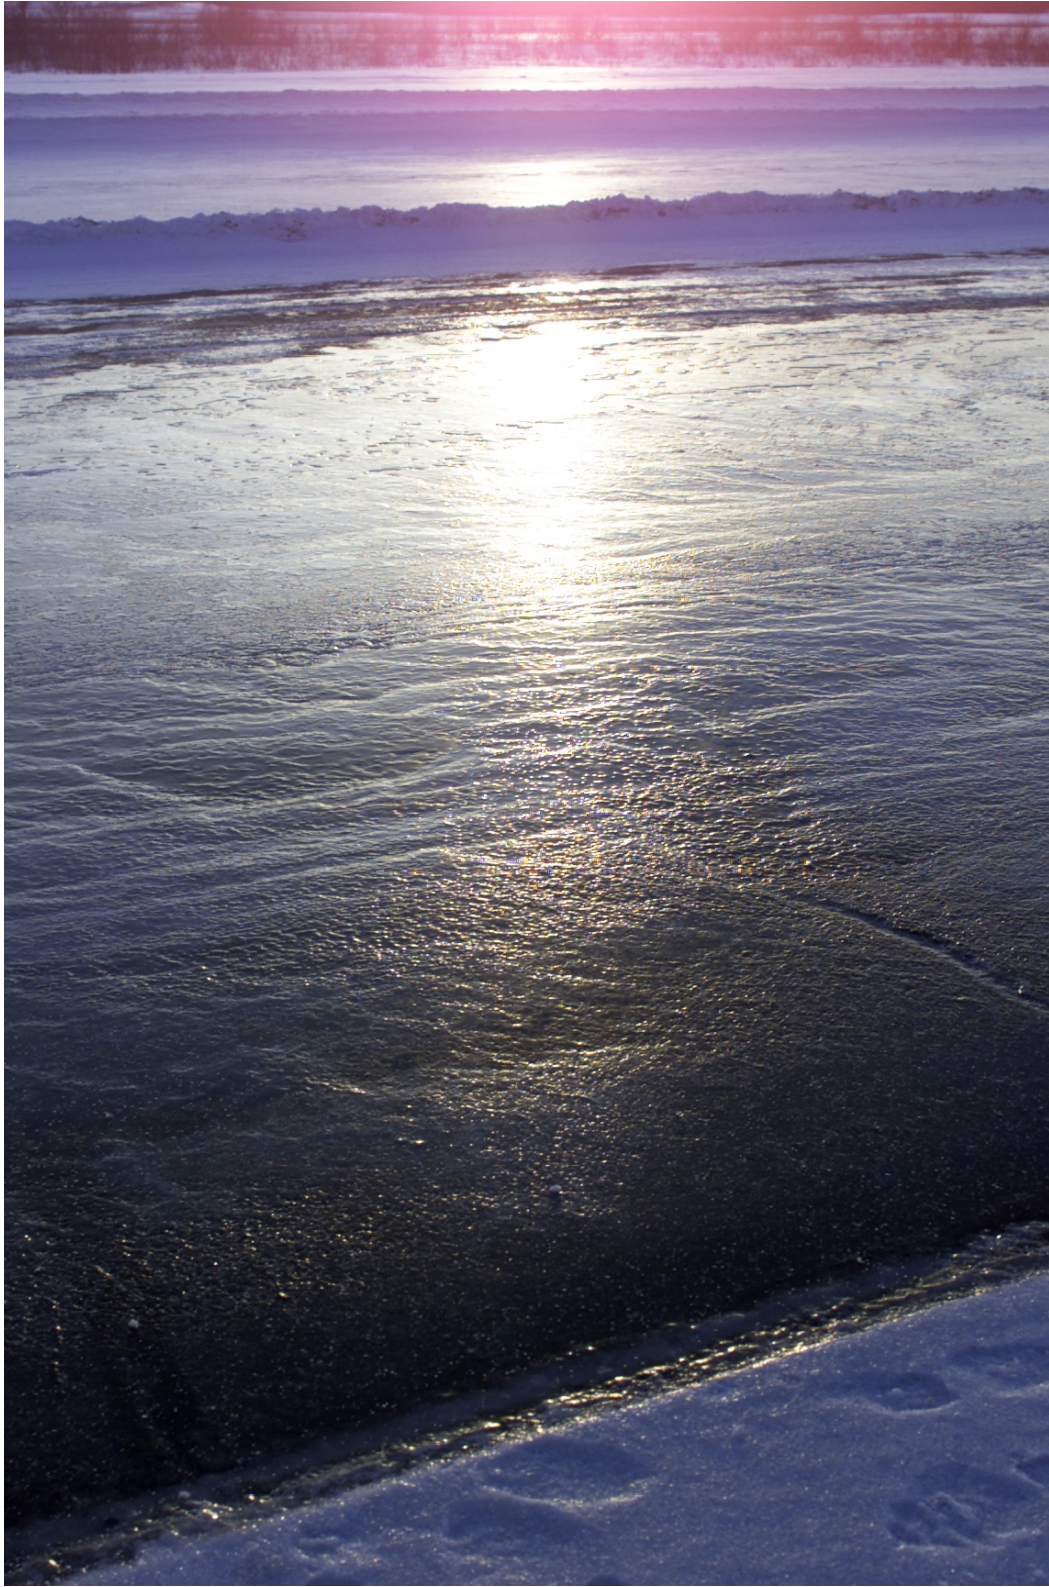
Figure 5a. A general view of the surface texture of the man-made ice strip after all the afternoon ground vehicle tests of 30 January 2002

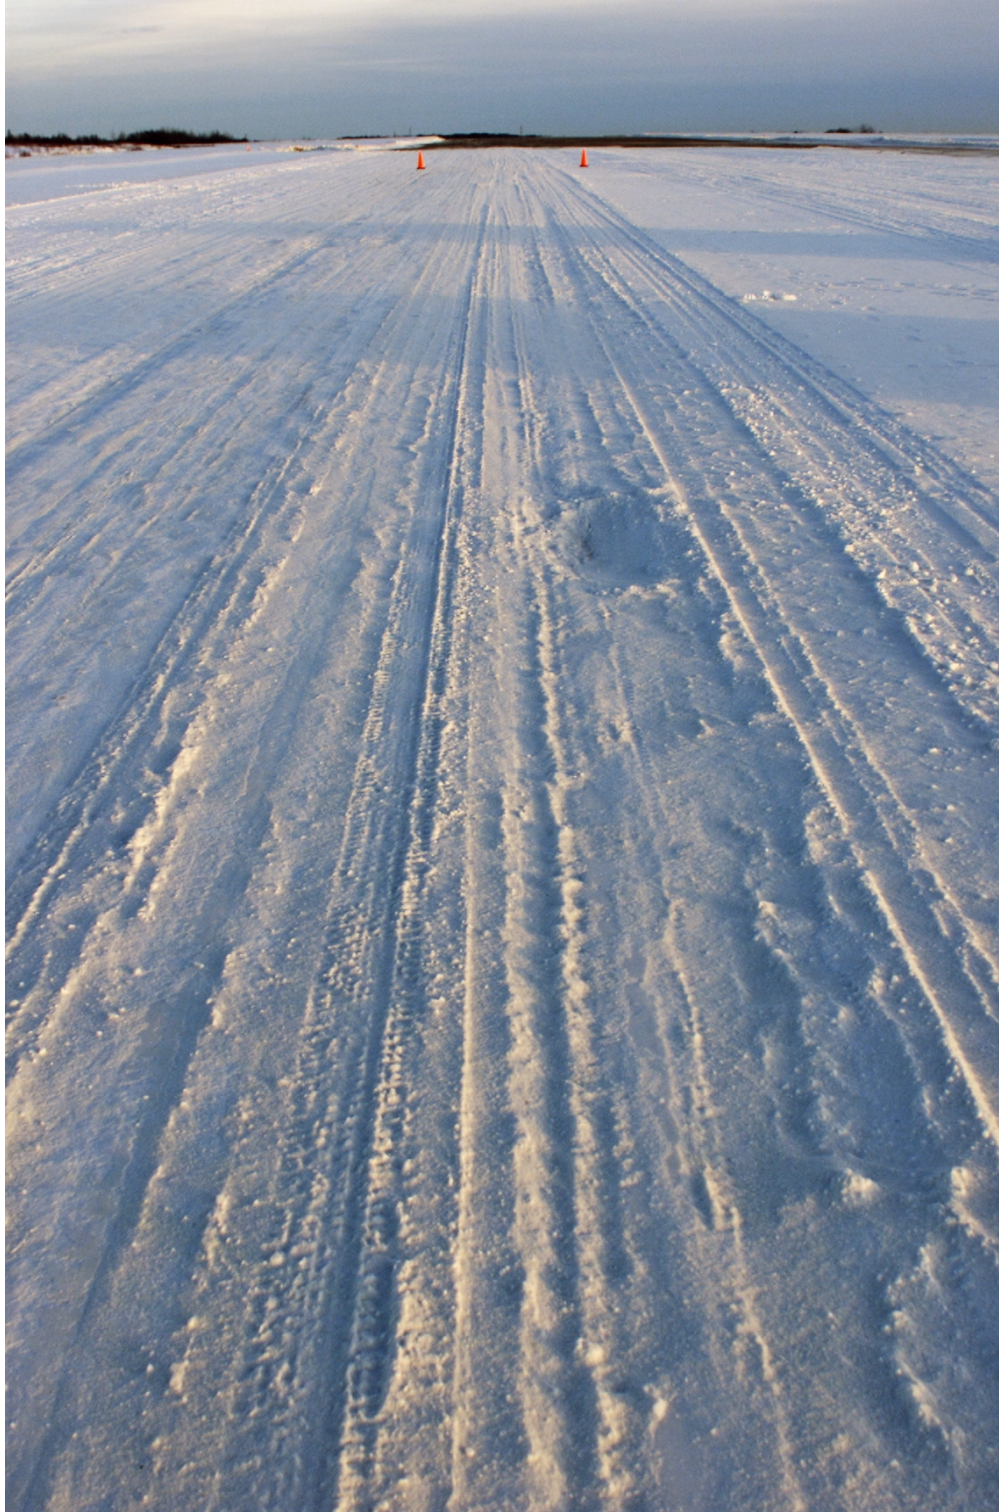
At this stage, the test strip was in a greatly altered (highly damaged) condition, as seen in Figure 5b. It was suggested that the location for next day's tests should be moved a few metres west of this strip.

Figure 5b. A general view of the altered conditions of the compacted snow strip on the east side of runway 13-31 after all the ground vehicle tests of 30 January 2002

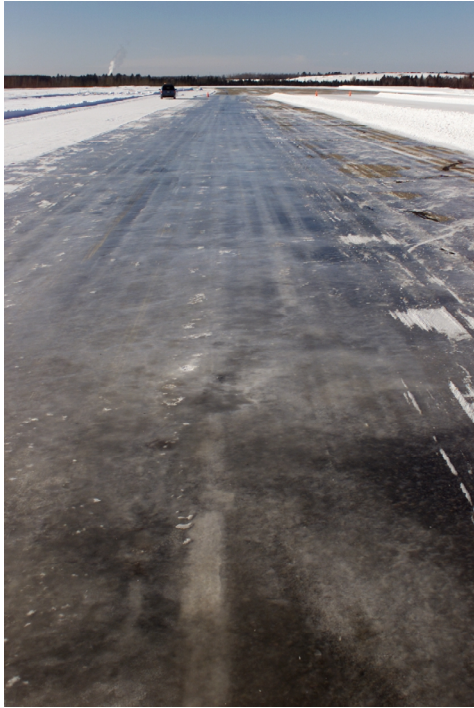
February 2, 2002 14:35
 North Bay, Ontario
 Test Number 02.33.05, Project 436
 Runway 1331, West of Center Line
 IRV/ERD Comparison, Variable Slip on ICE
 IRV-A/C Tire, High Load, High Pressure

Pre Test Conditions, Air Temp, -12.2 C,
 Surface Temp, -0.8 C, (Clear Ice) to -4.1 C, (Thicker, Bubbly Ice)
 The ice test strip thickness varied from 3mm, to 10mm. The ice was polished by
 test runs earlier in the day, and the strong sun had raised the temperature of
 the ice almost to the melting point in some areas.

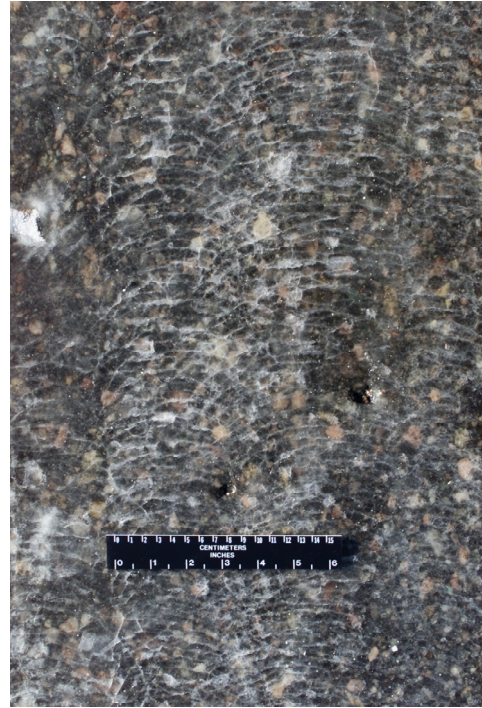
February 2, 2002 14:35, North Bay, Ontario
 Test Number 02.33.05, Project 436
 Runway 1331, West of Center Line
 IRV/ERD Comparison, Variable Slip on ICE
 IRV-A/C Tire, High Load, High Pressure
 Variable Slip on ICE

Conditions After 3 sets of Tests, Air Temp, -12.2 C
 Surface Temp, -1.1 C, (Clear Ice) to -3.8 C, (Thicker, Bubbly Ice)
 The ice test strip was now exhibiting severe cracking in some areas, and long strips
 of herring bone cracking were visible (shown). There were some areas in which the
 ice was crushed and water was visible.

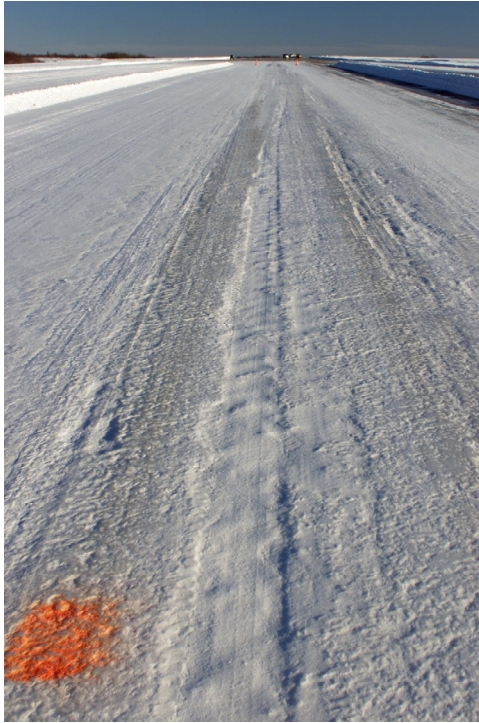
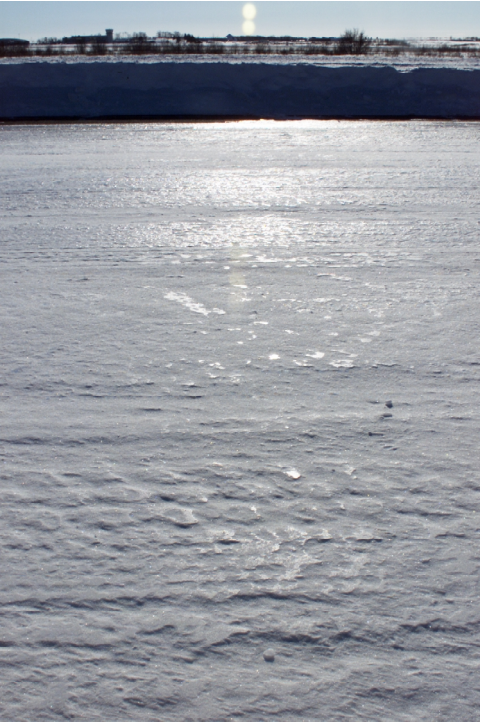
February 2, 2002 14:35
 North Bay, Ontario
 Test Number 02.33.06, Project 437
 Runway 1331, West of Center Line
 IRV/ERD Comparison, Variable Slip on COMPACTED SNOW
 IRV-A/C Tire, High Load, High Pressure

14:35 At this time, there was practically no wind and the sun was bright. The surface of the compacted snow strip was shining and revealed the texture well (Figure 7 a,b). For a general description of the compacted snow, see the test report for Test No. 02-33-02, Project 429. Although the strip was flat and free from any loose snow, except for the ruts created by the ERD tests in the morning, the entire strip had a texture that varied significantly along the width and length of the strip. As may be seen in Figures 7b and 7c, the surface texture could be related to the footprints of tires of heavy snow removal equipment used in the area.

Pre Test Conditions: Air Temp, -12.2 C
 Surface Temp, -10.1 C, (Compacted snow) to -10.2 C, (Icy Crust)
 Very uniform and highly compacted, with a texture caused by the fires of the heavy
 snow compactors. The surface was very smooth and uniform. The snow had been
 had caused an icy crust to form on the raised parts of the texture. (Visible in photo)

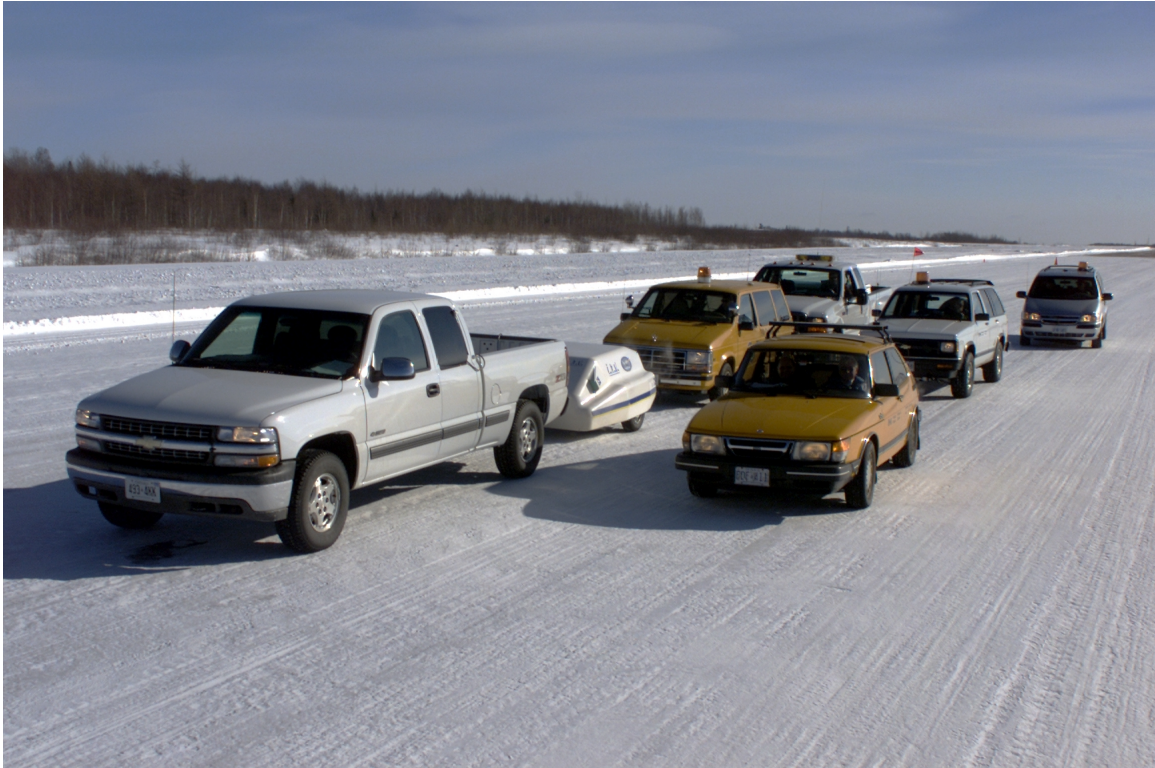
February 4, 2002 11:35
North Bay, Ontario
Test # 02.35.02/01, Project 102/101
Runway 13/31
NASA-GT, FAA-RFT, IRV,
TCSF-TURBO, FAA-BV11, ERD

Figure 8. Six test vehicles (ERD, IRV, FAA-BV11, FAA-RFT, NASA-GT and TC-SFT-TURBO) on the compacted snow on runway 13-31 on 04 February 2002 at 11:35

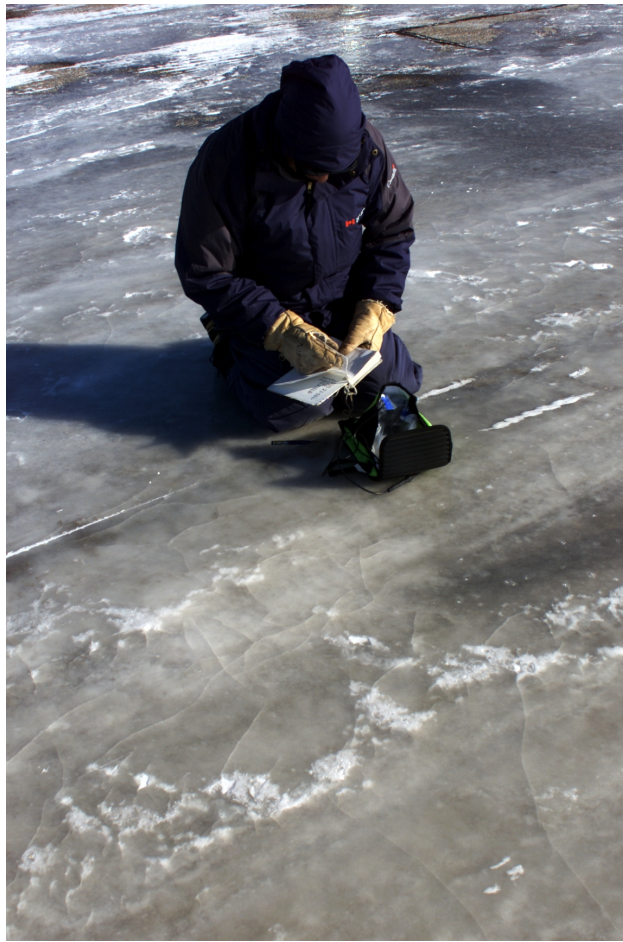
February 4, 2002 11:35
 North Bay, Ontario
 Test # 02.35.01, Project 101
 Runway 13/31, 13 Direction
 Ice was cracked throughout test surface
 as a result of snow removal that morning.

Post-test conditions: Clear, Sunny, Windy Day
 Air Temp. -19.5 C.
 Ice temp. -9 C. (Thin, Clear Ice)
 to -10.5 C. (Thick, Bubbly Ice)
 NASA-GT, FAA-RFT, IRV, TCSF-TURBO,
 FAA-BV11, ERD; 5 runs @ 65 km/h

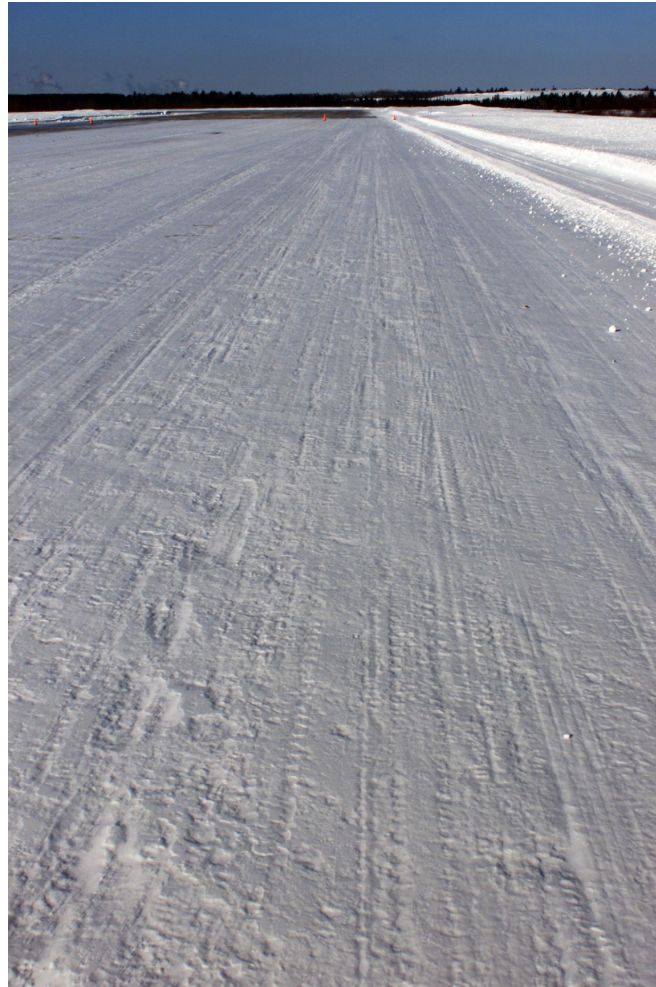
Figure 10. A general view of the compacted snow on the east side of runway 13-31 during the morning tests of 04 February 2002 (a) and a close up of the surface texture (b)

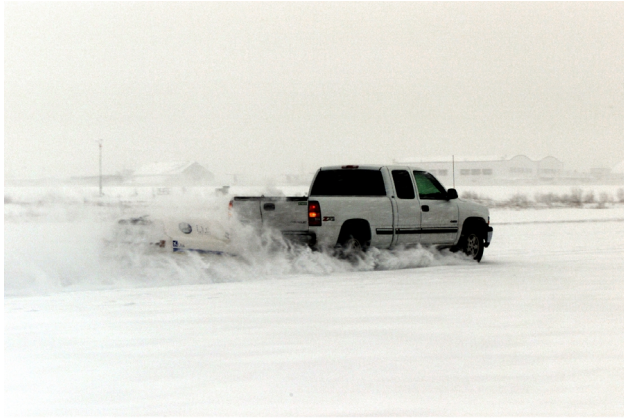
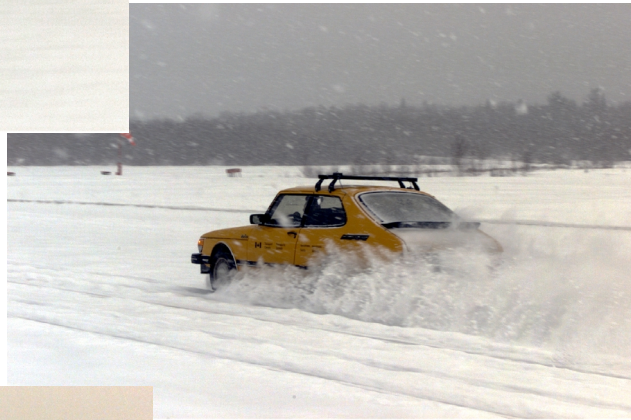
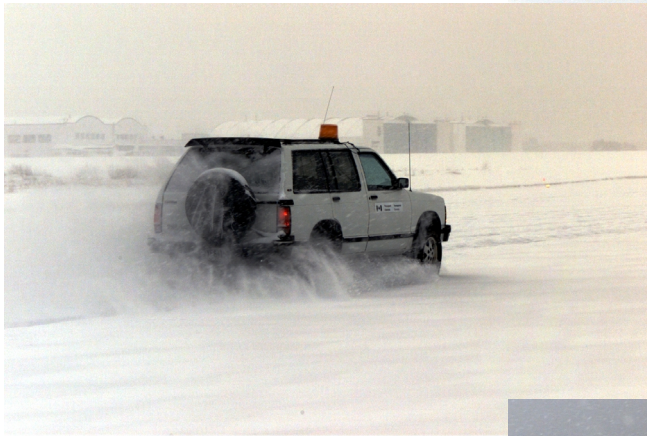
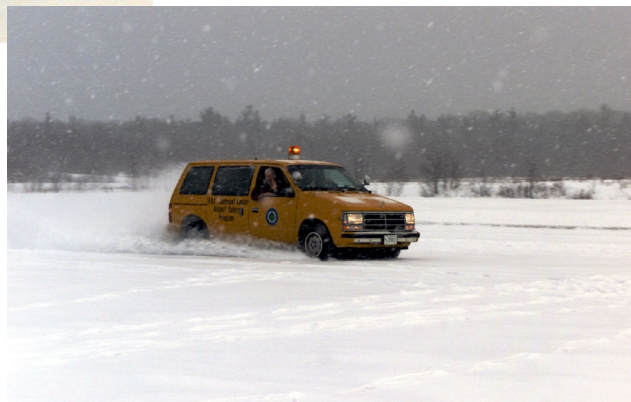
Figure 11. 05 February 2002 tests on runway 18-36 covered with 55 mm of fresh snow of density of 34 kg.m^{-3} , showing IRV (a), TC-SFT-TURBO (b), ERD (c) and FAA-RFT (d)

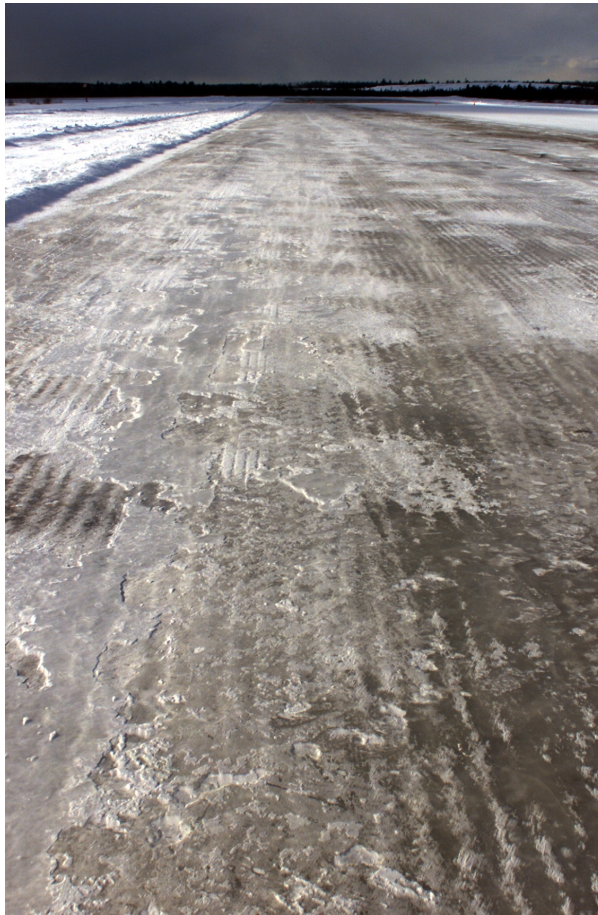
February 5, 2002 14:55 , North Bay, Ontario
 Test # 02.36.01, Project # 107
 Runway 13/31, Direction 13, 7 Runs at 65 km/h
 Pre-Test Conditions:
 Air Temp. -6.3 C., Ice Temp. -6.1 C.
 NASA-GT, FAA-RFT, IRV, TCSF-TURBO, FAA-BV11, ERD

Ice test section was reflooded the previous night; wind and blowing snow had caused the surface to become very non-uniform and crusty (shown). Snow removal equipment left the surface rough, appearing partially scarified. There were many areas of cracking and areas of frozen slush that had flaked off of the base ice.

Figure 12. Scarified man-made ice strip during the afternoon of 05 February 2002 showing a general view (top) and details of flaked ice (bottom)

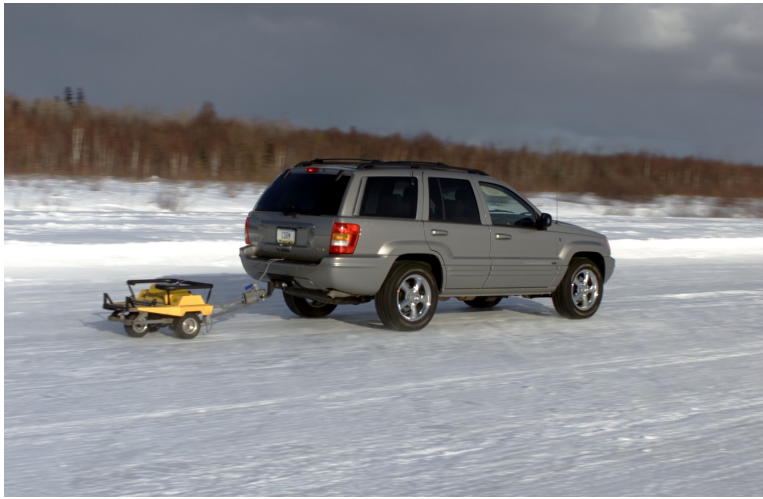
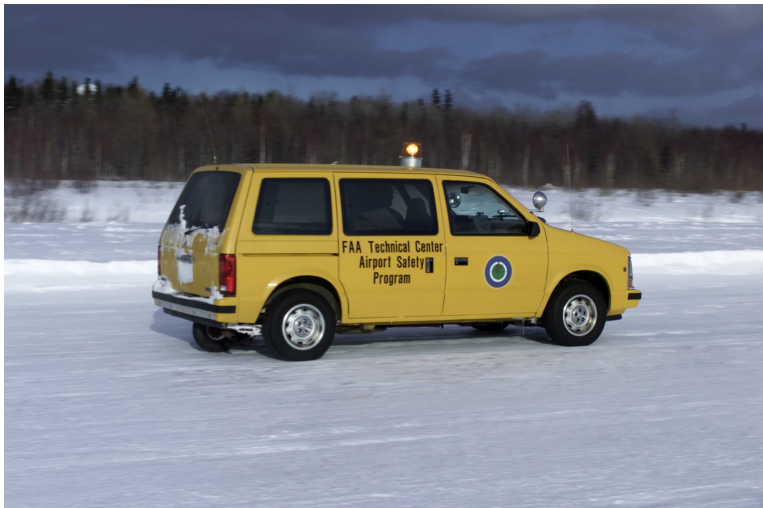
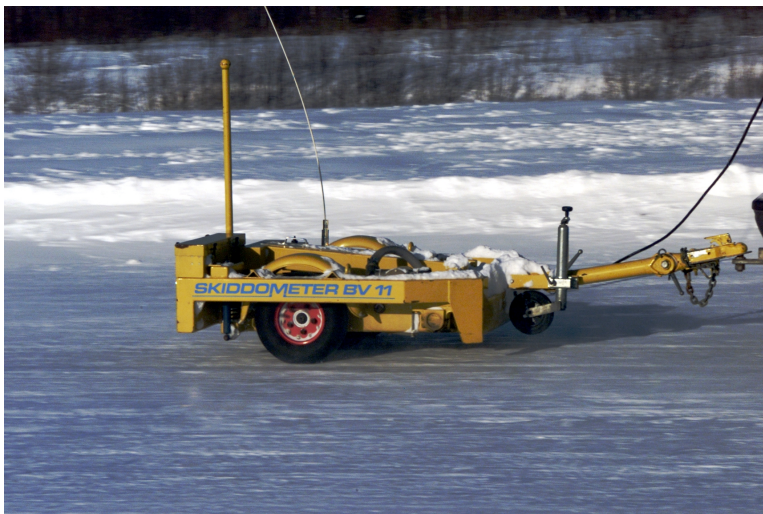
February 5, 2002 14:55
North Bay, Ontario
Test # 02.26.02
Project # 108
NASA-GT, FAA-RFT, IRV, TCSF-TURBO, FAA-BV11, ERD
7 Runs at 65 km/h

Figure 13. NASA-GT (top), FAA-RFT (middle) and FAA-BV11 (bottom) on compacted snow during the afternoon tests of 05 February 2002

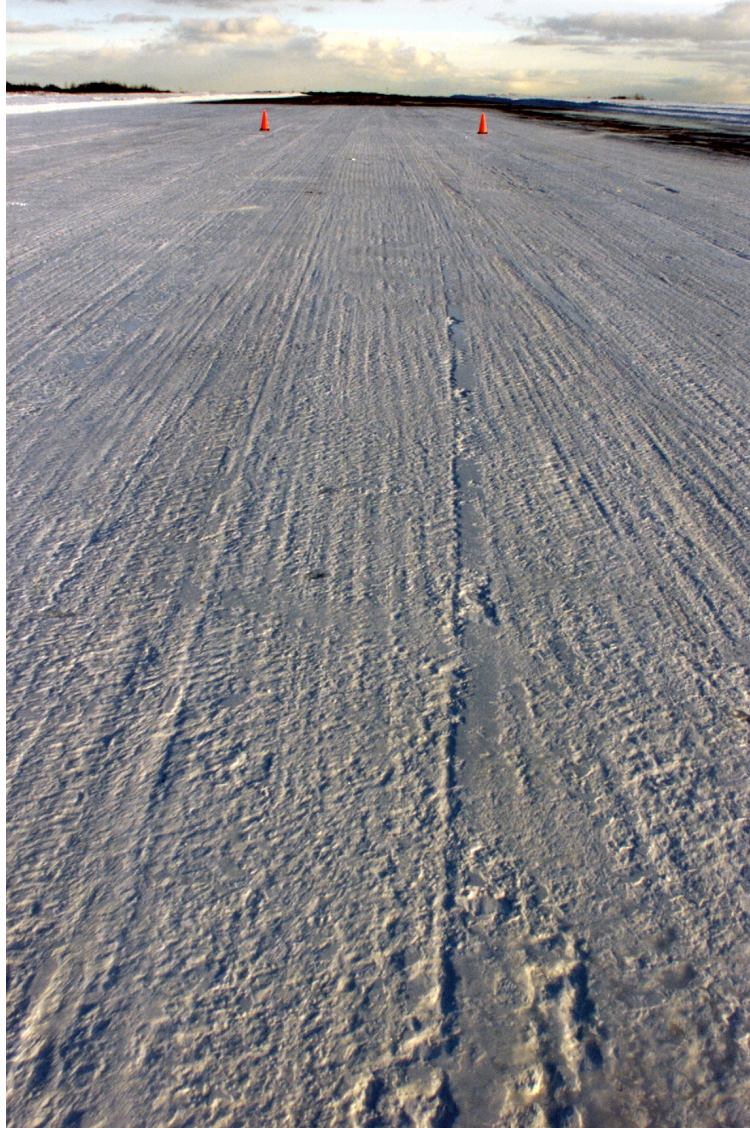
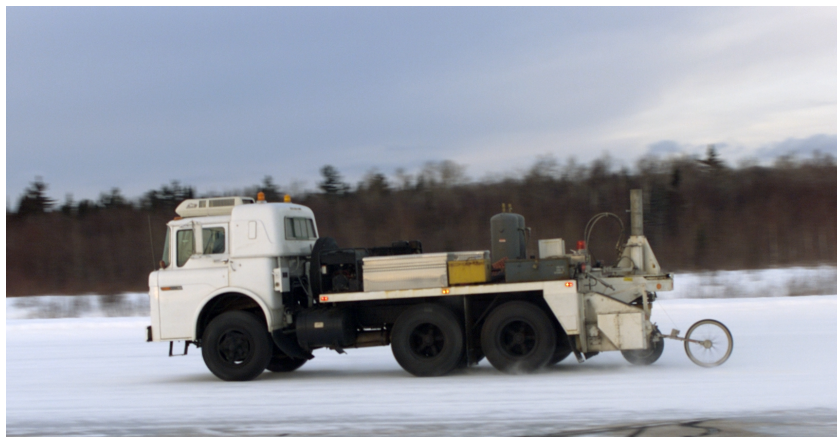
February 5, 2002 16:40
 North Bay, Ontario
 Test # 02.3608
 Project 109
 Runway 13/31, Direction 13
 Rough Compacted Snow on Center Line of Runway

Pre-Test Conditions:
 Air Temp. -7.4 C, Snow Temp. -9.7 C.
 Post-Test Conditions:
 Air Temp. -8.5 C, Snow Temp. -9.5 C.
 NASA-GT, FAA-RFL, IRV, ICSF-TURBO, FAA-BV11, ERD
 7 Runs at 65 km/h

Figure 14. Compacted snow strip on the centre-line of runway 13-31 (a) and the NASA-ITTV on the compacted snow (b) during the afternoon of 05 February 2002

Test No. 02-36-08, Project 109, was carried out on the compacted snow strip on the centre line of runway 13-31 (between #8 and #9 in Figure 1) from 16:40 to 17:05, when it was rather dark and the air temperature was decreasing with time. All the snow that had been deposited on this test strip was removed during the noon hour. The test strip was bare but rough. This series was a six-vehicle test involving the NASA-GT, FAA-RFT, IRV, TCSF-TURBO, FAA-BV11 and ERD. A total of seven runs were made at 65 km/h with each vehicle. The IRV was equipped with ribbed tires at high pressure.

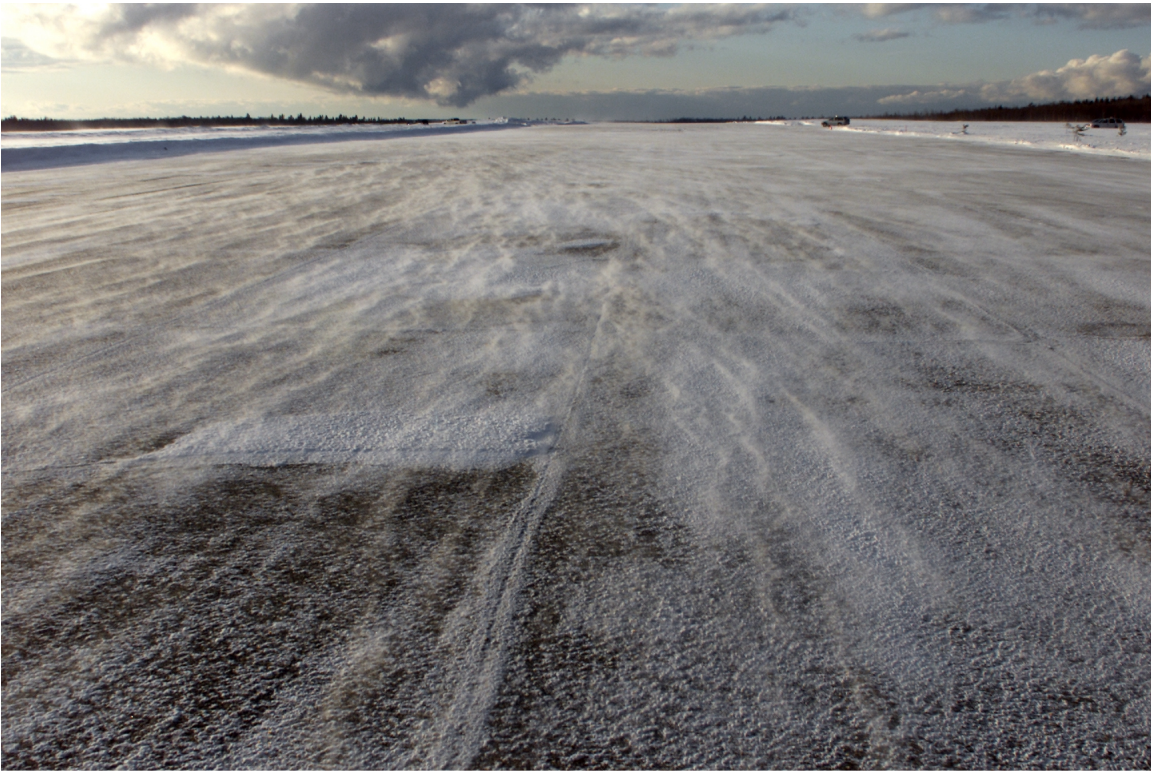
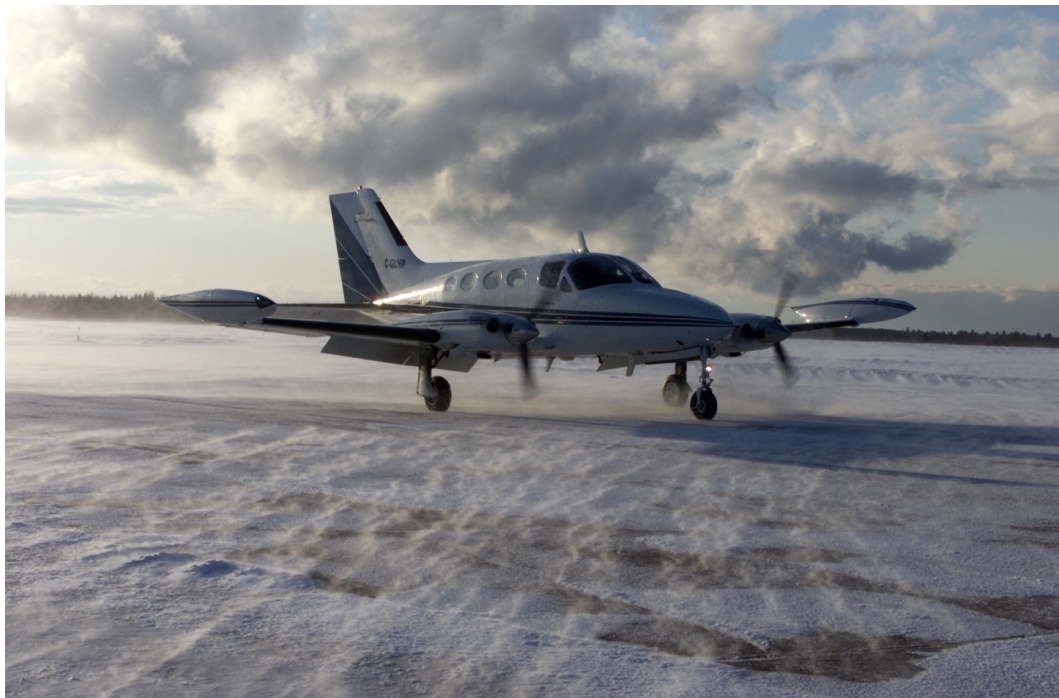
Figure 16. Conditions of runway 13-31 south at 16:25 on 07 February 2002 just prior to aircraft testing, showing (a) blowing snow, almost parallel to the length of the runway and (b) Cessna 414 preparing to test

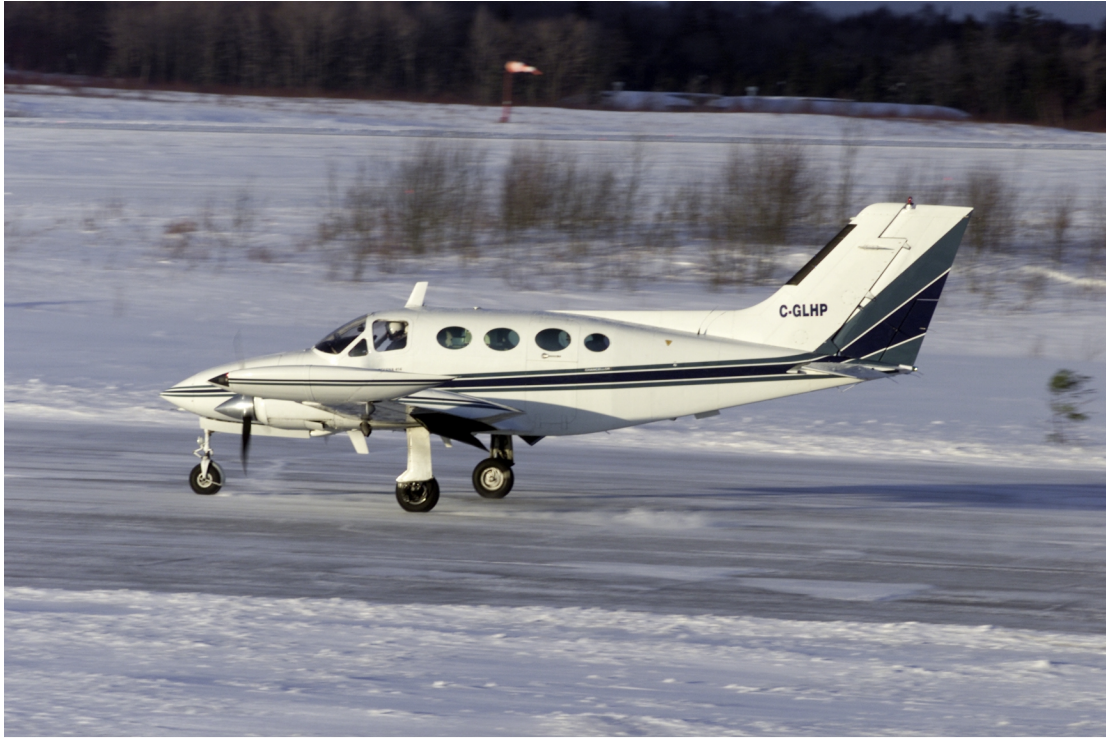
Figure 17. Cessna 414 testing (No. 02.38.05, Project 801) on runway 13-31 south in the evening of 07 February 2002 from about 16:30 to 17:30 (a) and aircraft tire marks in a snow patch (b, c). The marker on the snow is 150 mm in length.

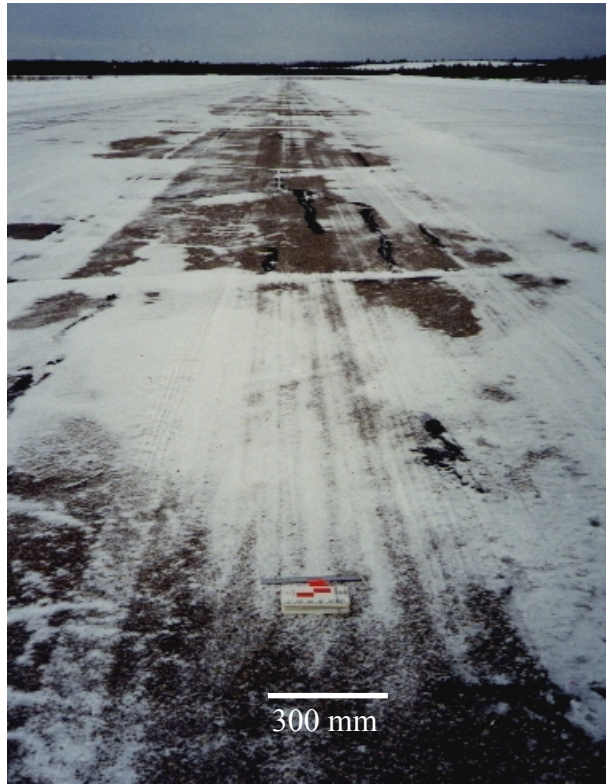
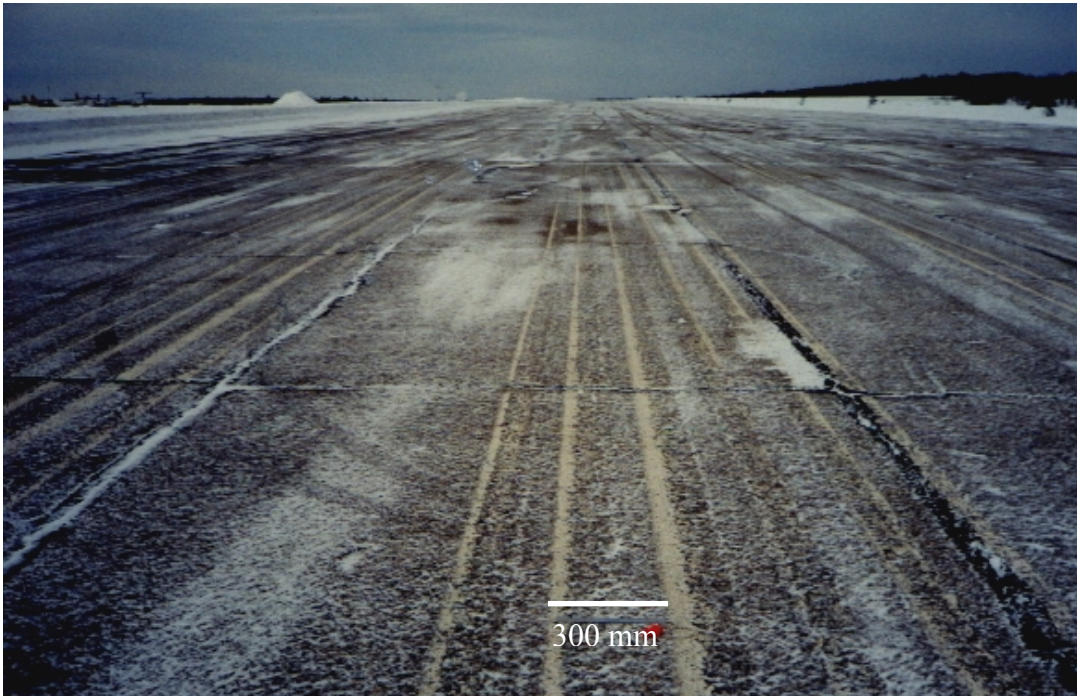
Figure 18. Conditions of runway 13-31 on 08 February 2002 during morning test no. 02.39.05, project 307, for the section north of runway 08-26 (a) and south of runway 08-26 (b)
